**SOUTH SAN LUIS OBISPO COUNTY SANITATION  
DISTRICT WASTEWATER FACILITY  
REDUNDANCY PROJECT**

**DELINEATION OF WATERS OF THE UNITED STATES  
AND STATE OF CALIFORNIA**

*August 2016*

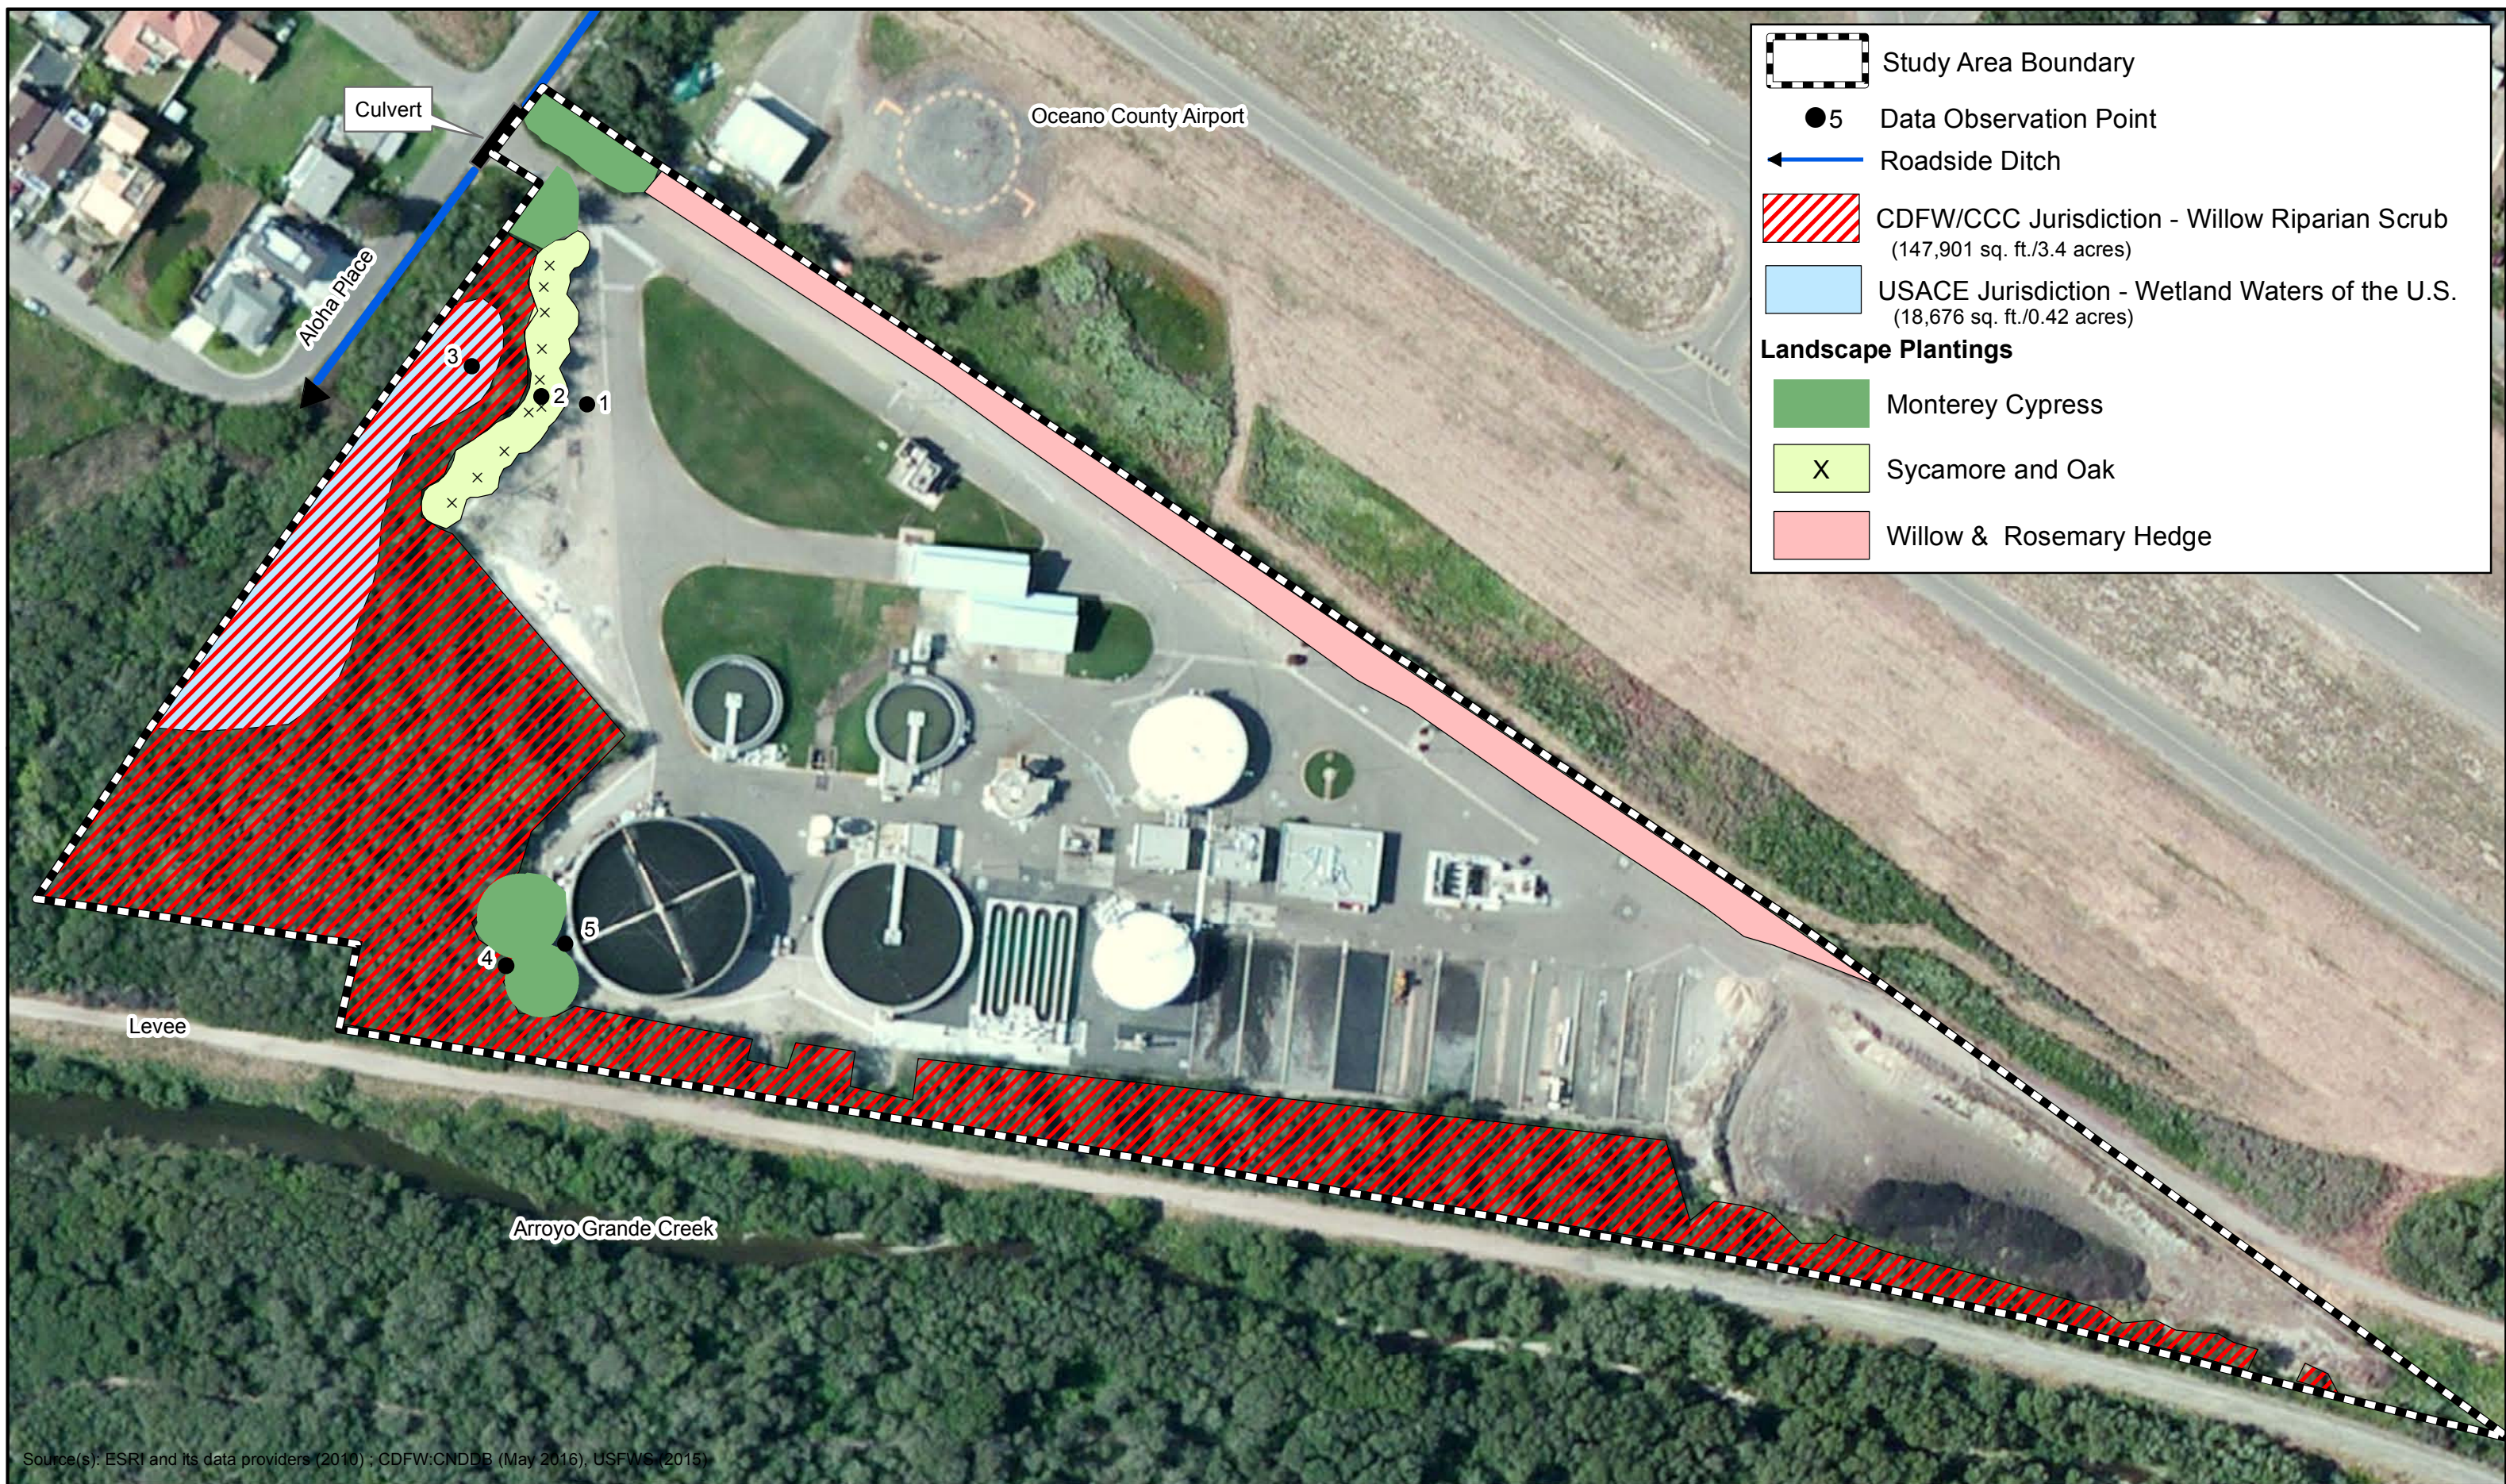
The investigation found wetland and riparian habitat associated with the Aloha Place roadside drainage ditch, Meadow Creek and Oceano Lagoon on the northwestern portion of the study area. Riparian habitat (arroyo willow riparian scrub) was also observed growing on the Arroyo Grande Creek levee along the southern edge of the facility. Based on the presence of defined bed and bank and/or ordinary high water mark features, hydrologic connectivity with Meadow Creek and the Oceano Lagoon and Arroyo Grande Creek and the Pacific Ocean, in concert with a predominance of hydrophytic vegetation and hydric soils conditions, it is expected that the wetland waters of the U.S. shown on Figure 4 would fall under the jurisdiction of the Corps pursuant to Section 404 of the Clean Water Act. The RWQCB and CDFW would be expected to take jurisdiction over all wetland and riparian areas shown on Figure 4. Similarly, all wetland and riparian habitats shown on Figure 4 would qualify as ESHA pursuant to the California Coastal Act.

It is important to note that the no wetland or riparian areas were identified within the active operations area of the plant including the area proposed for the Redundancy project. All of the jurisdictional features identified during this investigation and listed in Table 1 below are located outside the fenced and developed portion of the site.

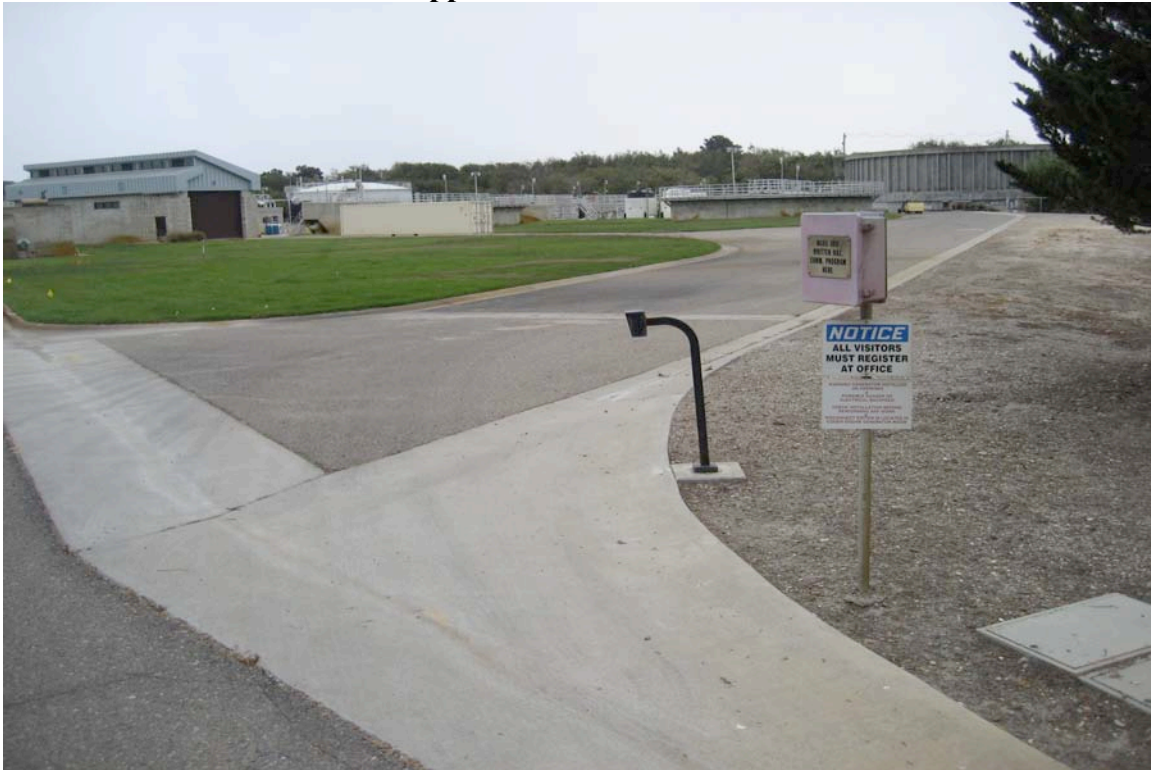
**Photo 1.** View southeast from facility entrance gate. Note buildings, lawn, and other developed features.

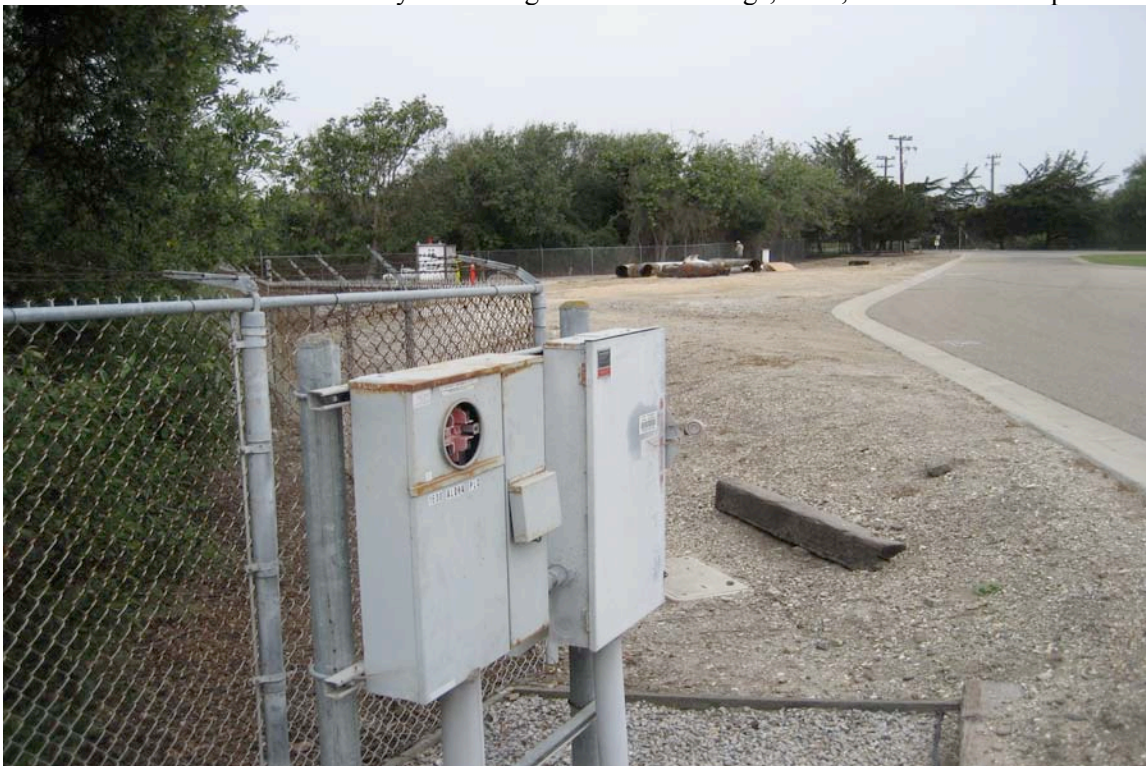
**Photo 2.** View north along western fenceline toward entrance gate. Note fenceline demarcating plant boundary with willows and planted sycamore and oak trees along fence outside the developed portions of the facility.

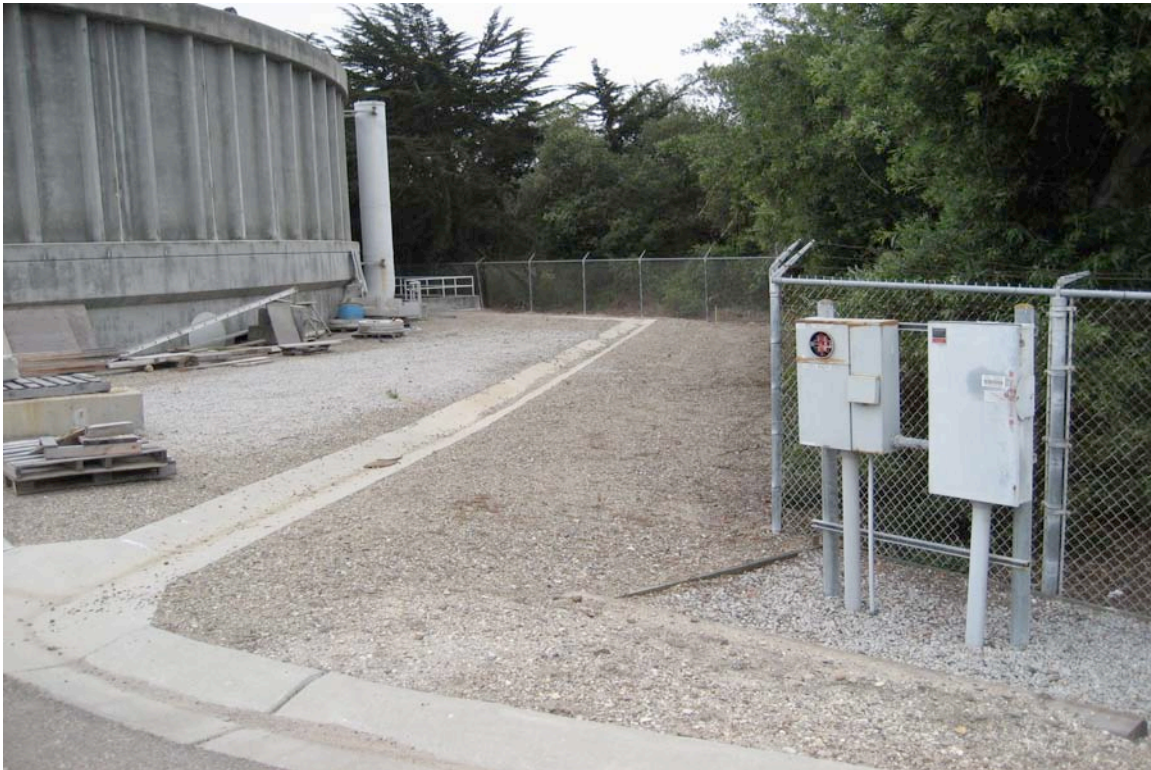
Data Point #5 documents conditions within the facility fence, on the southern side of the facility, opposite Data Point 4. No vegetation was rooted in or near the data point. Vegetative cover consisted primarily of Monterey cypress canopy with a small amount of arroyo willow branches hanging over the fence. This point contained dry sandy clay fill soils with gravels and cobbles, and did not meet any hydric criteria. The location is within the 100-year flood zone, but did not exhibit any positive evidence of wetland hydrology.

**Photo 3.** View southwest along western fence line showing general location of Data Point #5. Note cypress and willows outside fence with existing development within the facility.

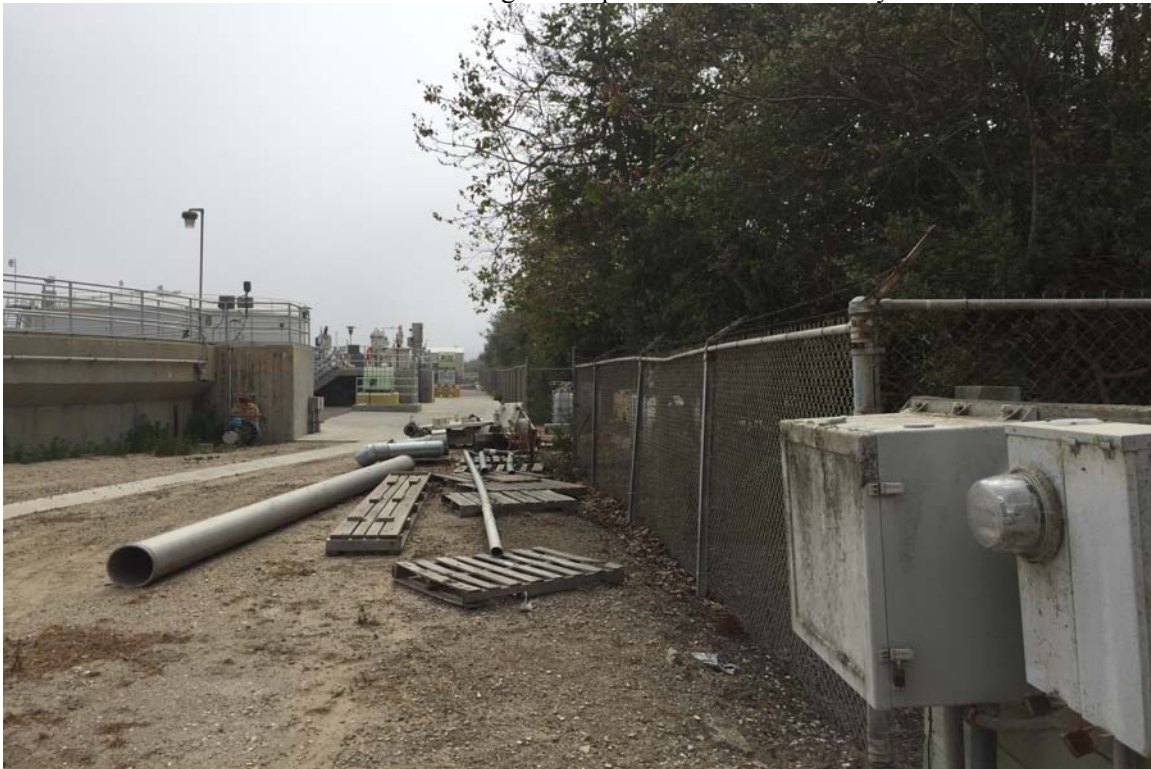
**Photo 4.** View of southern fenceline opposite the Arroyo Grande Creek levee, looking east. Note maintained fenceline with occasional willows extending over the fence.

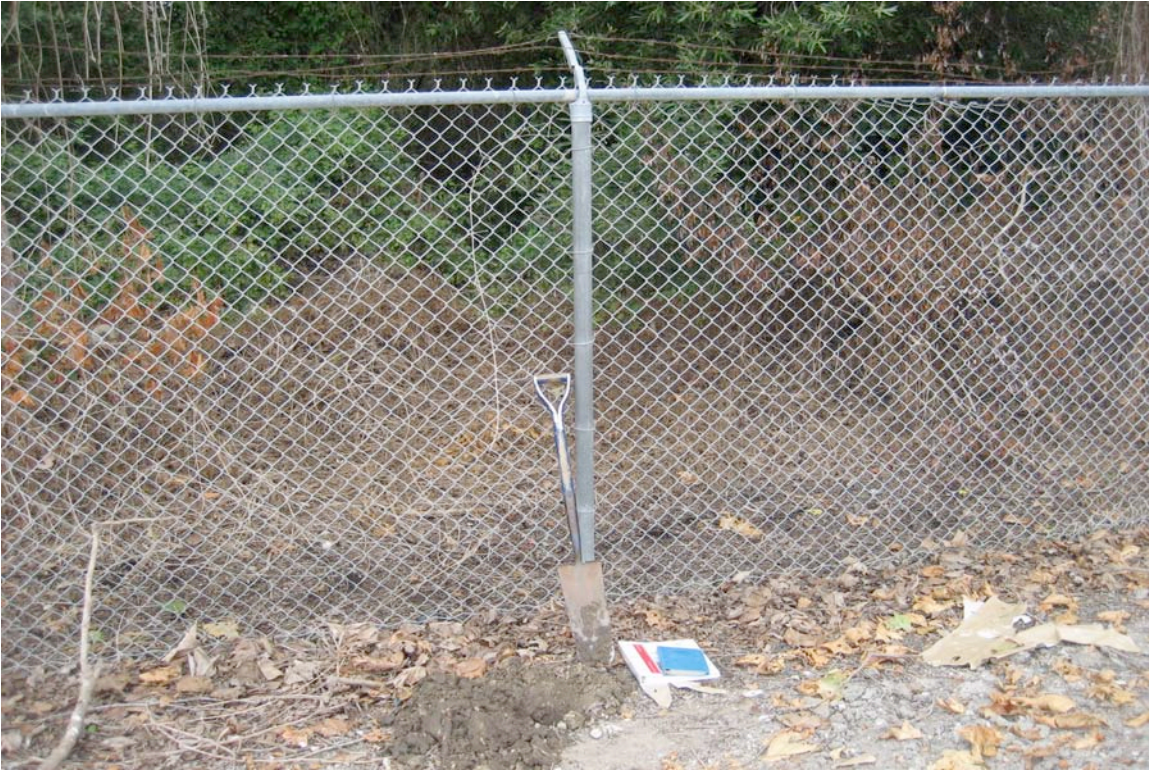
Data Point #1 documents conditions at the western portion of the site, at the fenceline within the active portion of the Facility. The area consisted of bare soils and base rock with little to no vegetative. Immediately adjacent to the fence were planted sycamore and oak trees, with small inclusions of willow and native vines at the edge of the sample area. This point contained bare sandy clay fill soils, with gravels and some larger cobbles also present. The soil did not meet the hydric soil criteria. The point location is within the 100-year flood zone, but did not exhibit any positive indicators of wetland hydrology.

**Photo 5.** View of Data Point #1 inside the western fenceline looking west toward Aloha Place. Note approximate 10-wide vegetation maintenance zone along outside of fence.

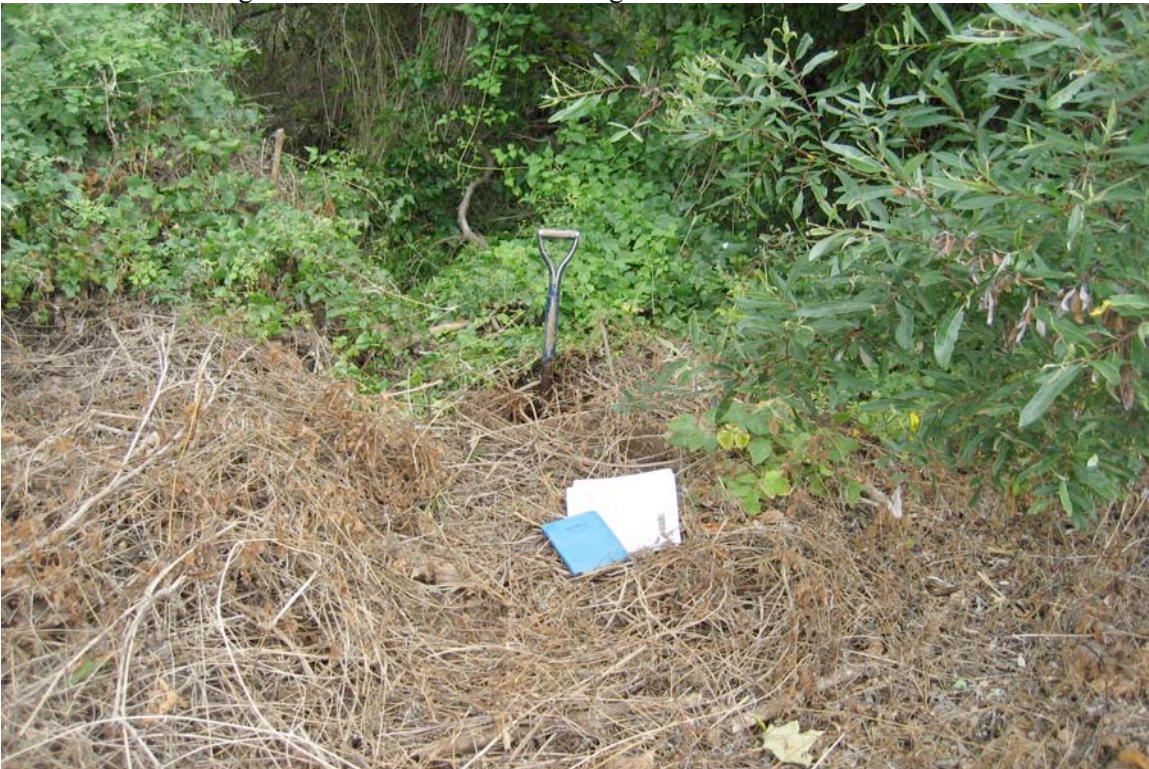
Data Point #2 documents conditions at the top of a small earthen berm that generally forms the top of bank of the wetland associated with the Oceano Lagoon system, including a small roadside channel along Aloha Place. Vegetative cover consisted of a dense canopy of arroyo willows and

vines (creek Clematis and blackberry) rooted in the riparian area behind the planted sycamore trees. This point contained a layer of leaf litter above dry, single grain sand. No hydric soil indicators were observed, and therefore, did not meet the hydric soil criterion. The location could potentially flood under extreme ponding conditions in the Oceano Lagoon following large storm events, but did not exhibit any evidence of wetland hydrology during the investigation.

**Photo 6.** View of Data Point #2, looking west toward Aloha Place. Soil pit located on berm above small channel, at edge of maintained zone along the fenceline.

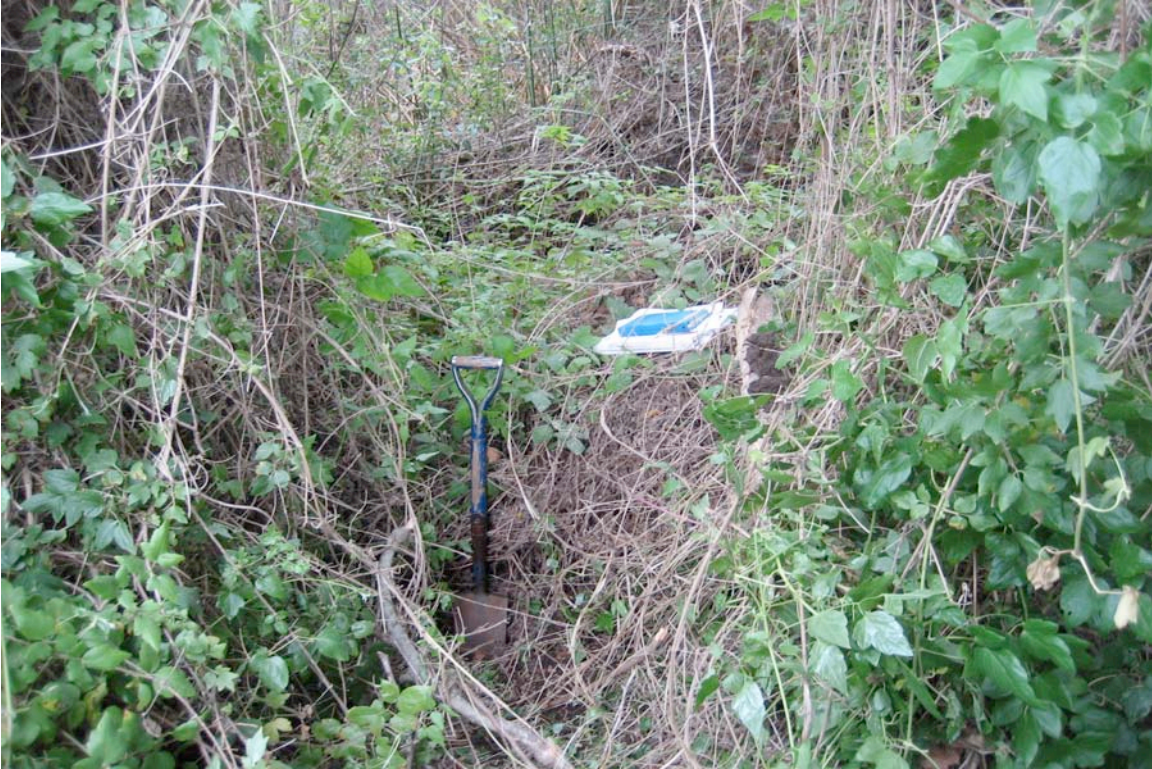
Data Point #3 documents conditions within the bottomlands associated with the Oceano Lagoon including hydrologic input from the small roadside channel along Aloha Place. Vegetative cover consisted of a dense canopy of arroyo willows and vines rooted in the riparian area, and a small amount of California bulrush in the lowest portion of the channel. This point contained a layer of leaf litter above moist sandy loam and sandy clay soils, with faint redoximorphic features present in the lower horizon. The soil did not meet any hydric criteria as described in the Arid West Manual, but is assumed to function as a hydric soil due to location, vegetation, prolonged saturation and adjacency to ponded water. The location contained standing water within the sample area, and is expected to contain flowing and ponded water on a seasonal basis.

**Photo 7.** View of Data Point #3, in the lower portion of the channel, looking west. Note dense riparian vegetation in this area. Surface water was present just beyond data point demarcated by shovel.

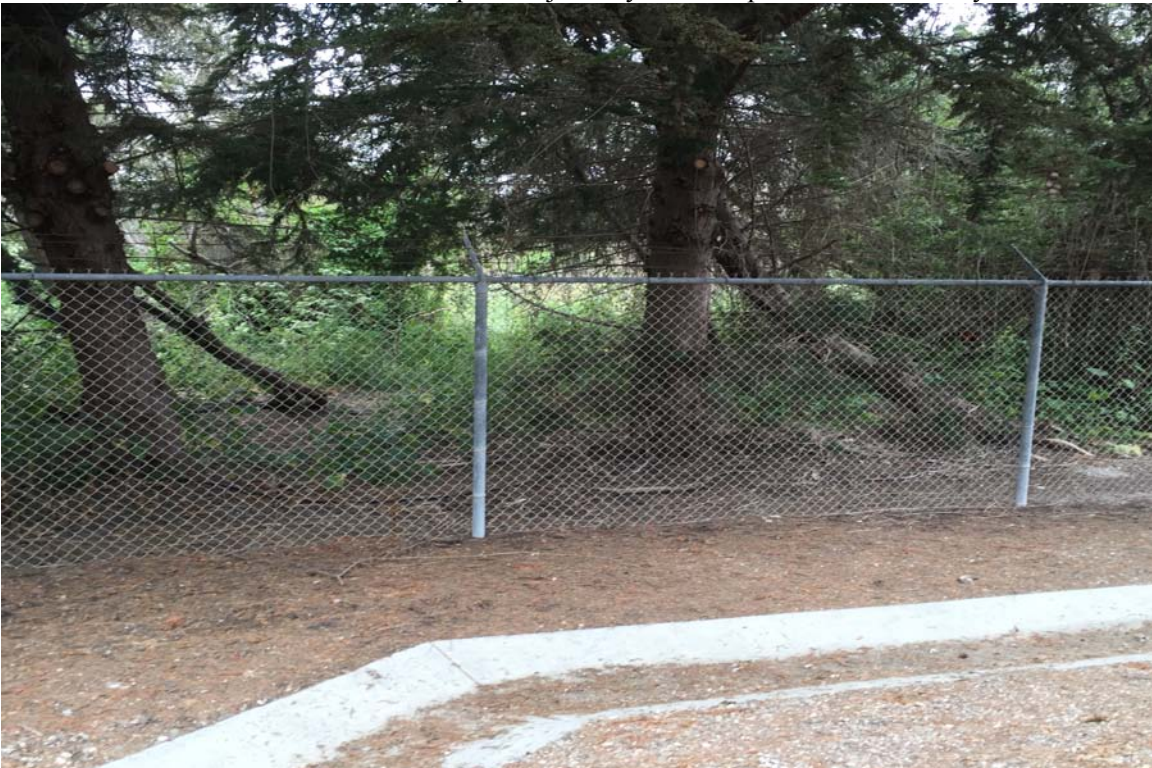
Data Point #4 documents conditions on the southern side of the facility, between the fenceline and the outer edge of the levee berm. Vegetative cover consisted of a mixed canopy of Monterey cypress and arroyo willow. This point contained dry sandy and clayey soils with gravels (likely associated with the construction of the levee), and did not meet any hydric criteria. The location is within the 100-year flood zone, but did not exhibit any evidence of ponding or flowing water during the investigation, and therefore, no positive indicators of wetland hydrology were present.

**Photo 8.** View through southern fenceline to Data Point #4 location, looking southwest toward the levee berm. Note cypress and willow trees, and sparse understory vegetation dominated by annual upland species. Data Point #5 was positioned inside fenceline on maintained base rock near the concrete ditch.

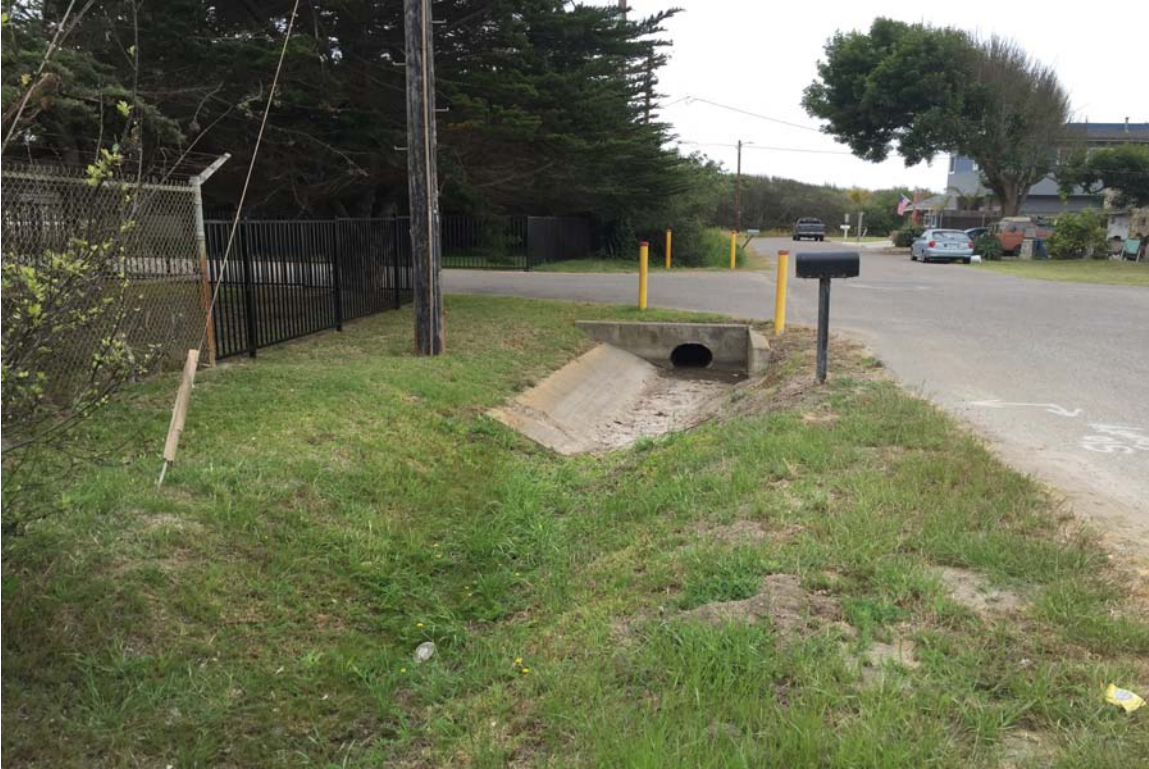
**Photo 9.** Westerly view of roadside ditch near facility entrance.

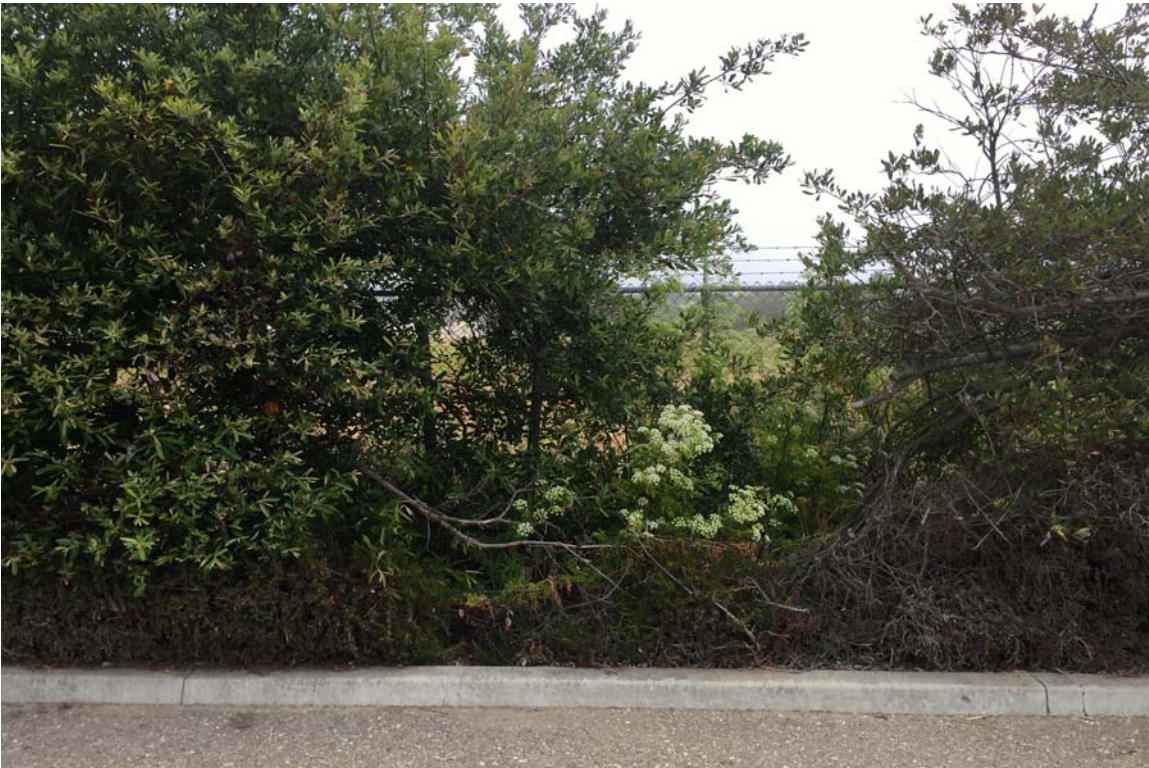
**Photo 10.** Northeasterly view of willow and rosemary hedge planted along parking lot. The fence in the background separates the site from the Oceano County Airport.
